Landslide Study of Gaj Watershed, Beas River Basin, Himachal Pradesh, India

Abstract

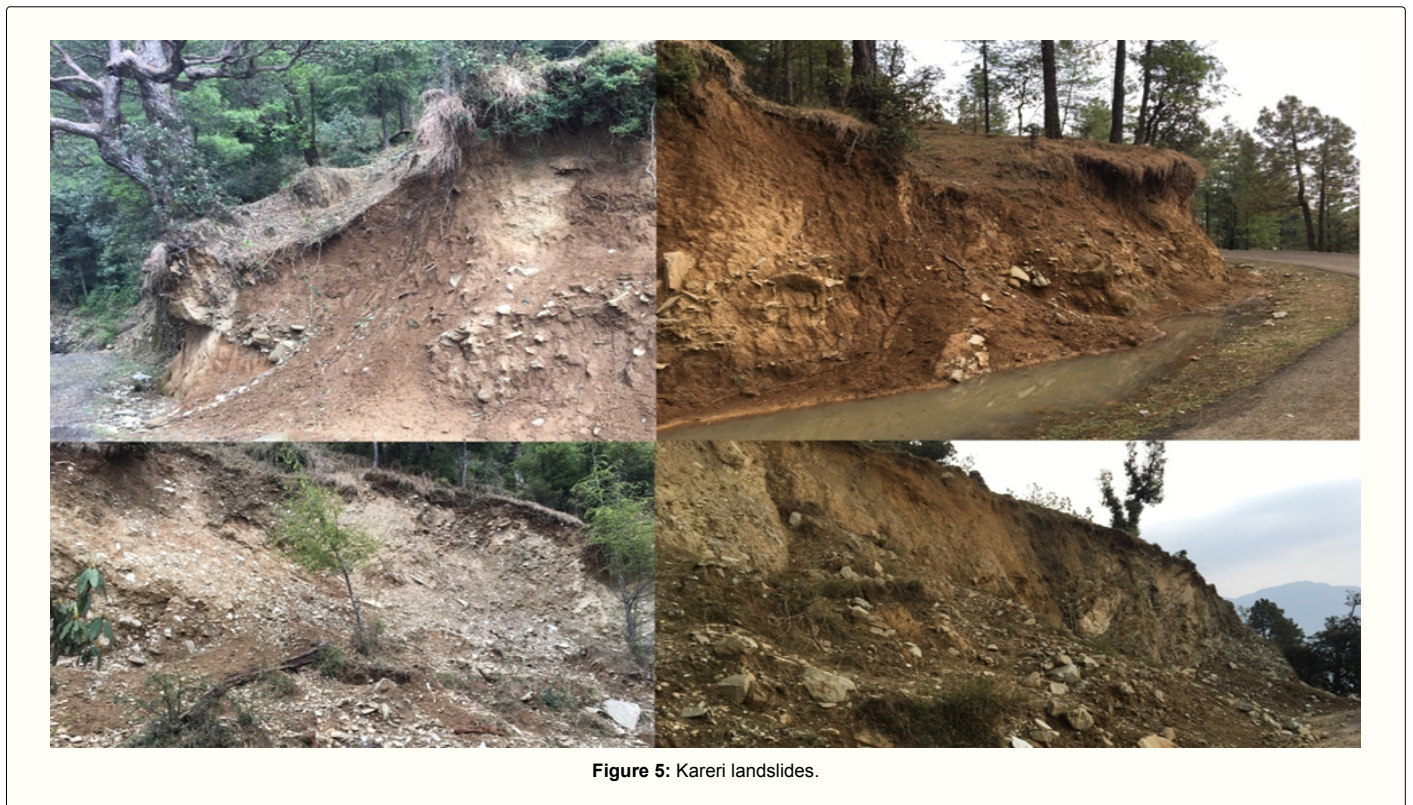
Figure 5: Kareri landslides.

Kareri landslide zone: Kareri village is situated on the upper reaches of the watershed area and falls in the moderate steep slope zone with 30°-45° slope ranges. The area is experiencing rapid civilization growth, which is demanding more shelters and roads for communication. Being the hilly area, most of these demands have sculpted the slopes.

The area is mostly of Chail Formation and erratic of granites are also encountered.

The main causative factors here are tectonic movements, road cutting and settlement on steeper slopes. Precipitation and seepage are other minor causative factors. Toe cutting due to roads along with poor drainage management of roads have enhanced the failure and if not properly assessed, there are chances for further failures. Retaining walls along the roads are suggested to check the failure due to hydrological factors, such as infiltration and seepage. If needed, a strain gauge can be introduced along with retaining wall. A proper drainage management along the road sides is needed. Trenches made with concrete are suggested to check the toe cutting of slopes during rainy season.

Land failures may be minimized by slope treatment also. Steeper slopes can be graded and turned gentle which may decrease the risk of failure. It is suggested to keep settlement away of these steeper slopes. Keeping in view of the seismic sensitivity of the area, administration is suggested to keep an eye on further settlement and to imply scientific measures for further development (Figure 5).

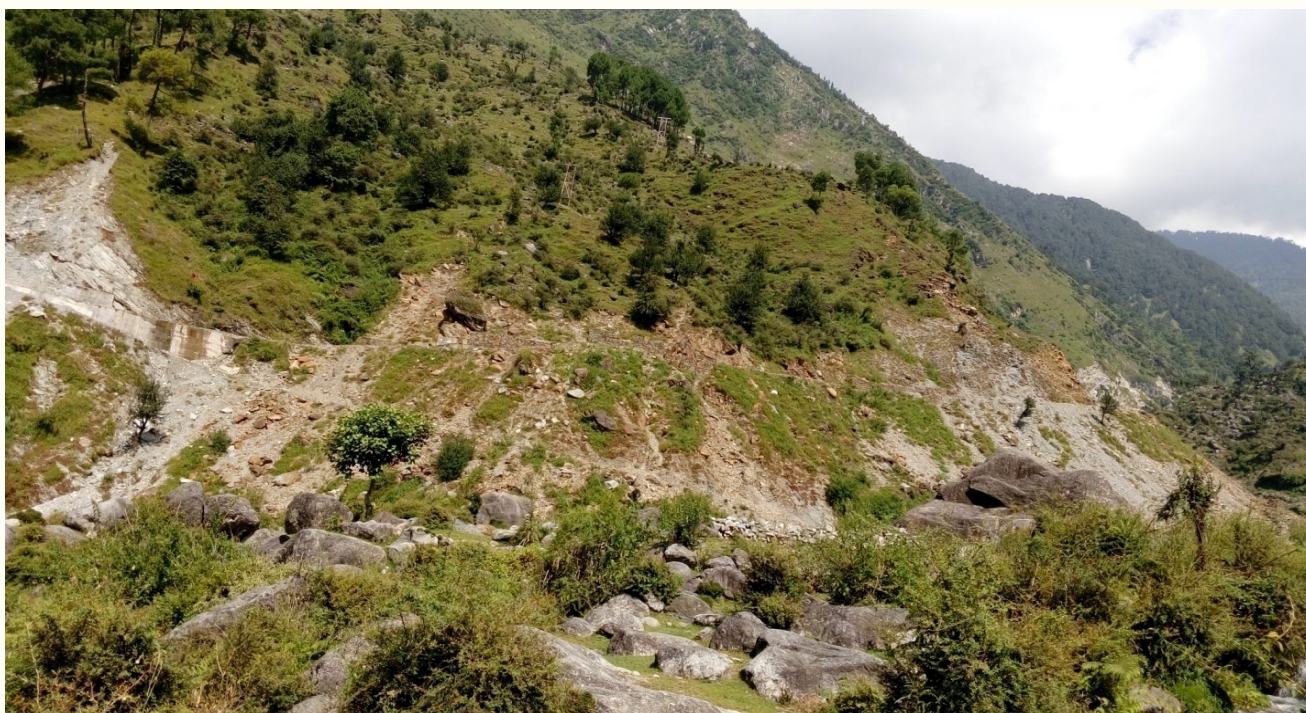
Figure 6: Ghera landslides.

Ghera landslide zone: Ghera village is situated on the western side of Dharamshala Township. A small hydroelectric project is also made on Gaj Khad at Ghera village. The connecting road from Ghera to Kareri is not well metalized and proves useless even after a moderate rainfall (Figure 6).

The entire village is highly sensitive in terms of tectonic activity and displays a beautiful diversity of lithology. Some important lithological formations are encountered here at short intervals of distance. The entire area is sandwiched between Chail Thrust and Main Boundary Thrust. There are great tectonic activities along these structural breaks and are well evident and exposed in the area in the forms of major

landslides. Along with this drastic tectonic setting, high precipitation and steeper slopes have turned the area into a major landslide zone, to which under cutting due to stream and toe cutting due to road is also prominent. The slide zone is so great in size that it engulfed a major portion of road and number of trees and vegetation. The rock type is Phyllite and the failure is mainly due to infiltration, toe cutting by road and tectonic activity along Chail Thrust. Poor drainage management along the road sides is also a major causative factor.

Further failure could be assessed by employing retaining walls and proper drainage measures along the road, as hydrologic factors are the main triggering factors.

The Ghera-Kareri forest road should be well metalized immediately along with suitable drainage measures to prevent it from frequent slope failures which are creating havoc in the area. Retaining walls with strain gauges are needed to provide strength to fragile slopes. So that the economic and ecological development of the area could be restrain.

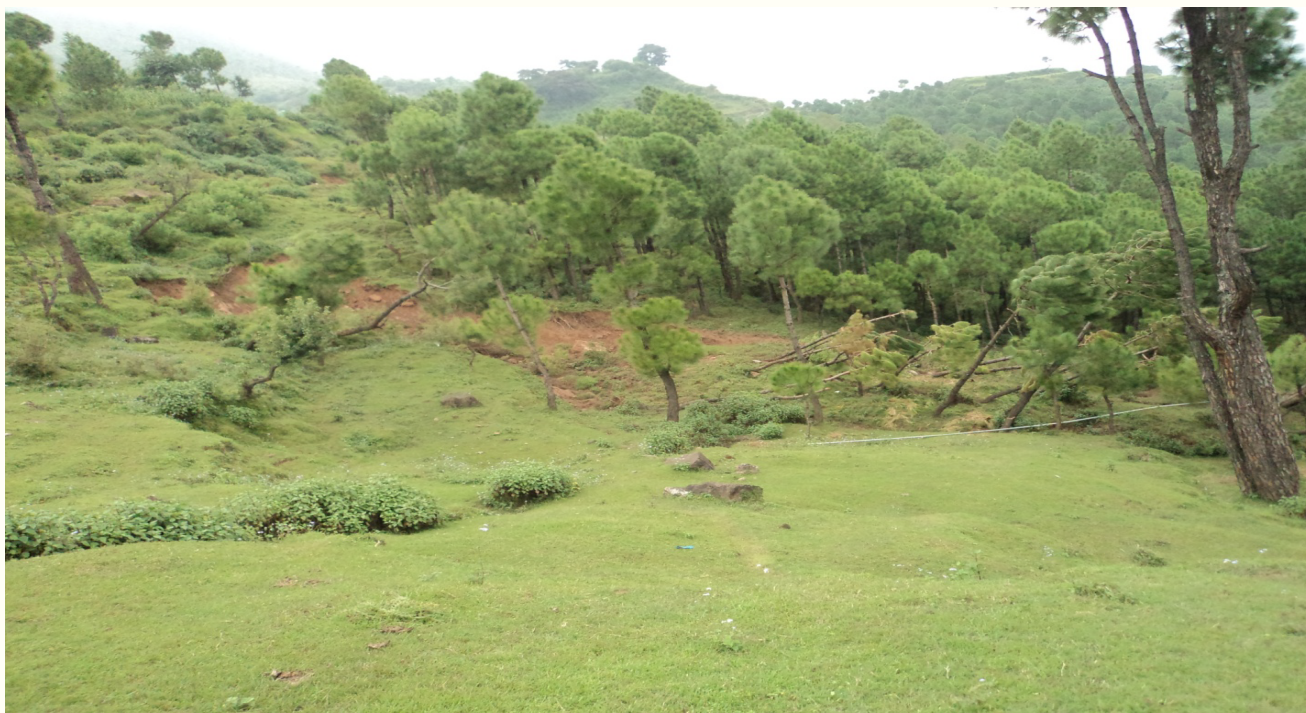
Figure 7: Creep at Salli.

Salli landslide zone: Salli village is situated on the upper reaches of the watershed area in the northwest side. Lithology of the area consists mainly of purple sandstones with clays of Subathu Formation. Area receives moderate to heavy annual rainfall. Village is surrounded by lush green coniferous vegetation. Evidences of slow movements in the form of creeps are encountered in the area. Debris is mainly composed of clay, sandstones and vegetation. Tilting of tree trunks and bended pipes are evidence of slow moving creeps. Infiltration due to frequent precipitation is the main causative factor of this soil failure. If not properly accessed and managed, this movement could turn a big hazard in near future. Slope treatment and plantation can check further movement (Figure 7).

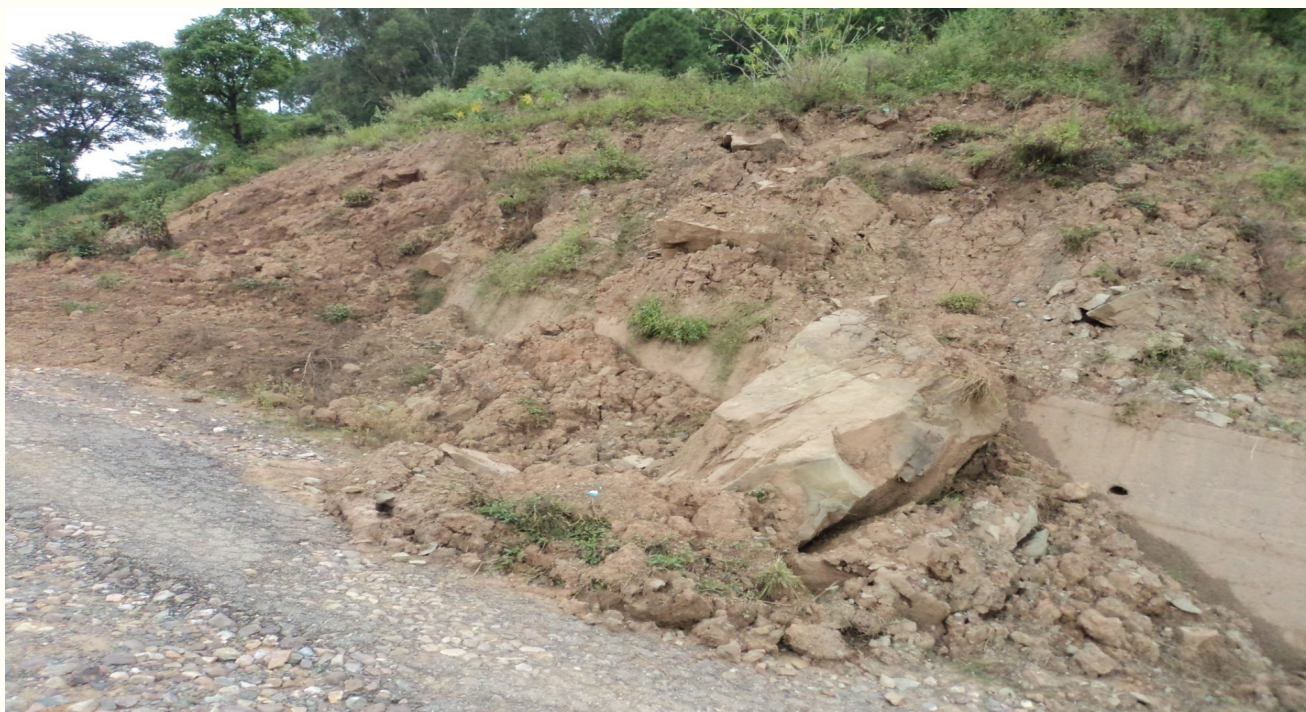
Figure 8: Drini landslide.

Drini landslide zone: Drini village is situated on a ridge and this ridge is a water divide of Gaj Khad watershed and Dehar Khad watershed. Village is geologically and tectonically very sensitive as a major structural break namely Drini Thrust is there. The thrust has named after the village. A variation of lithology is encountered in the villege. Drini Thrust separates Dharamshala Group from Siwalik Group.

Buff colored sandstones of Dharamshala Formation and conglomerates of Upper Siwalik Formation are well exposed in the area, especially in various landslides (Figure 8).

Besides being tectonically sensitive, the village is well populated and various anthropogenic activities adding up to disturbance, in terms of land degradation and erosion. The debris is composed of sandstone and vegetation and the scrap shows that it is a rotational slide. Toe of the slide has damaged some extent of road.

The main causative factor of this slide is movement along the fault zone. Also, poor drainage along road in this tectonically active zone has doubled the risk of land failure. Further movement in the side can risk the road and hence can disturb the communication. To check further disturbance, proper drainage measures are needed and to check further loss of scarp, a retaining wall is proposed.

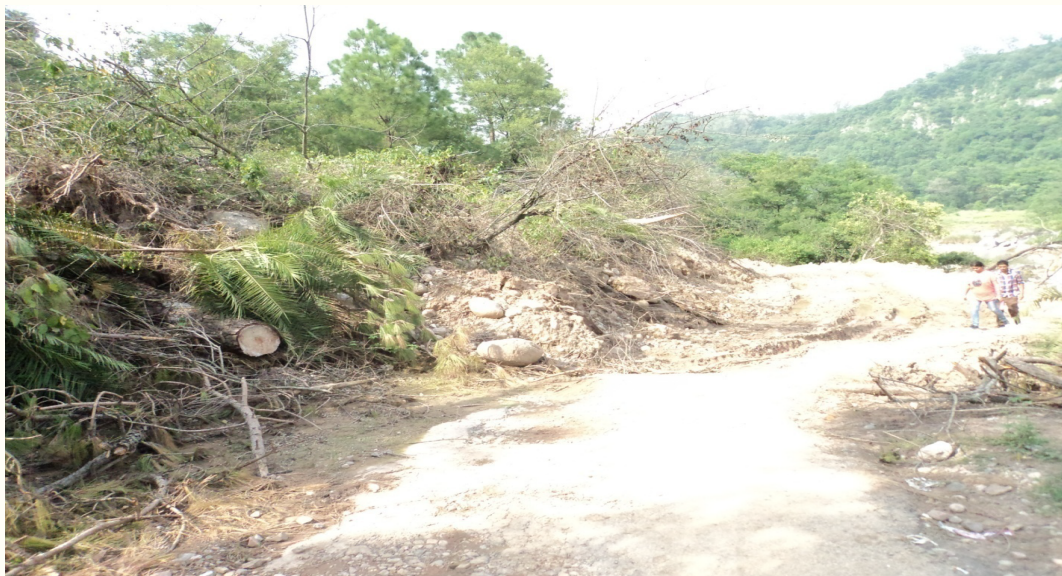
Figure 9: Balla landslide.

Balla landslide: Balla is a village, near Tatwani hot spring and near the confluence of Gaj Khad and Khauli Khad. The lithology of the area mainly comprises of sandstones and clay of Siwalik Group. The area experience frequent landslides during rainy season. The main causative factors for these frequent landslides are seepage on slopes due to rainfall and road cuttings along slopes. The extent of the slide was so large, that it blocked the road for couple of months. Debris is composed mainly of sandstones of Upper Siwaliks, clay and a huge amount of vegetation. The landslide affected the road as well as affected the vegetation. Entire road was washed away with the debris flow. Slope strength was decreased due to road cutting to which heavy rainfall further decreased the holding strength and resulted in mass failure. Poor drainage along road was also a reason for the land failure (Figure 9).

The road is the main connecting link to Tatwani hot spring, which is quite famous tourist place. The road is frequently damaged during rainy season and gives a huge setback to tourism. To minimize further risk of

land slide in this zone, some remedial measures are suggested. The main cause of most of the slides in the region is poor drainage management. Well concreted trenches along the road are needed. To stop further movement of debris along the slope, retaining wall is proposed.

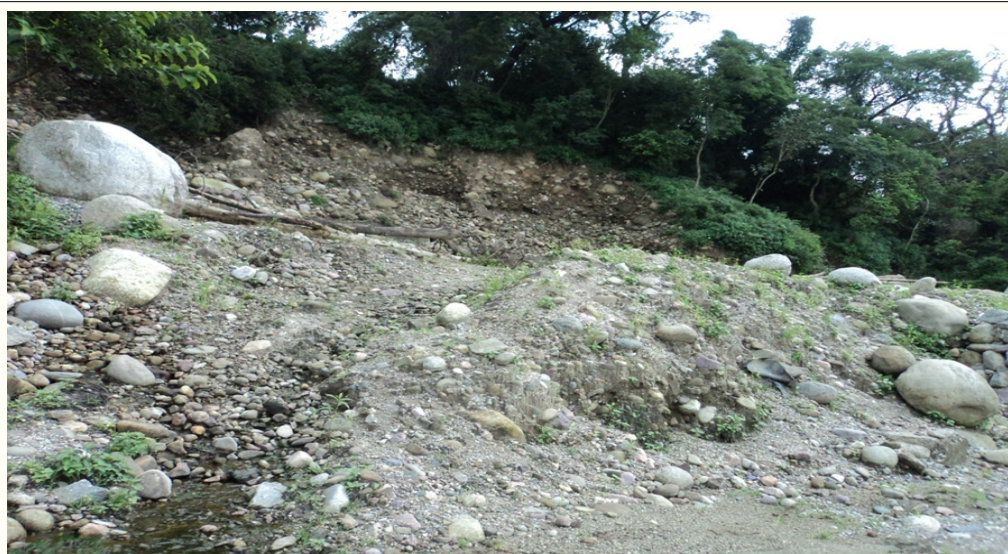
Figure 10: Rait landslide.

Rait landslide: The displaced debris comprises of huge mass of conglomerate, clay and mud, heaped down on road. Uphill to the slope is highly vegetated and inhabited. The slide damaged a portion of road and disturbed the communication. Landslides are frequent in this zone

and recently retaining wall was applied to stop the failure, but the wall was also damaged in recent landslide. The main reason for this slide is toe cutting due to road, reducing the slope strength and habitation on upslope. The problem is further aggravated due to heavy rainfall. Further, widening the road is making slopes steeper and unstable. The slide can remain active for a long time as the crown portion is tilting downwards and the frequent rainfall will further crumple the slope. A strong retaining wall with strain gauge is needed to check the further risk of failure. Proper drainage along road can also help in slope strengthening (Figure 10).
