Review of Spatial and Temporal Distribution of Landslides in Tanzania

Abstract

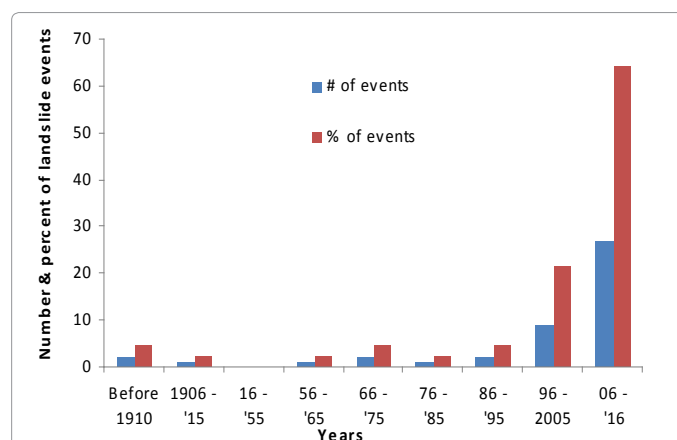
Figure 1: Histogram plot of landslide events in Tanzania (<1910 to 2016). Note that this histogram was constructed based on the information from archived sources and field exploratory study. Thus, there may be other landslide events that went unreported or whose details are unavailable.

A total of 45 landslides were identified and mapped over a span of 106 years in Tanzania. Of these, 5 were mapped based on field exploratory study while the remaining 40 were based on Google Earth search and image interpretation, aided by reviewed information from archived sources. The 45 landslides and their details are presented in the specific sections of this inventory as mentioned in Table 2. Based on this inventory, the earliest recorded landslides in Tanzania date back to about 100000 years ago and involved collapses of Kibo crater rim at Mt. Kilimanjaro [26-29]. The reviewed sources provide no record of damage to property, fatalities or other impacts from these collapses. The most recent reported landslide event in Tanzania occurred on May 4, 2016 in Lwangwa and Lupata wards, Rungwe district, Mbeya region and involved rotational slumps (Table 2). Generally, the period 1996-2016 reported more landslides than any other period covered by this inventory (Figure 1). Low but fluctuating number of landslide events is noted before year 1910 and the period between 1910 and 1995. The period between 1916 and 1955 presents an unusual case, where no landslide event was reported. Of all landslide events, mudslide/flows, rock falls, rotational slumps and mine collapses seem to have relatively higher frequency of occurrence than other types (Figure 2).

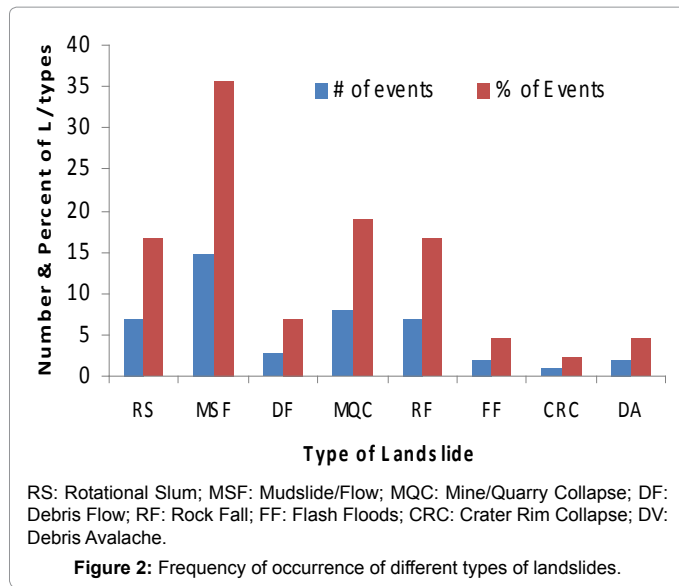
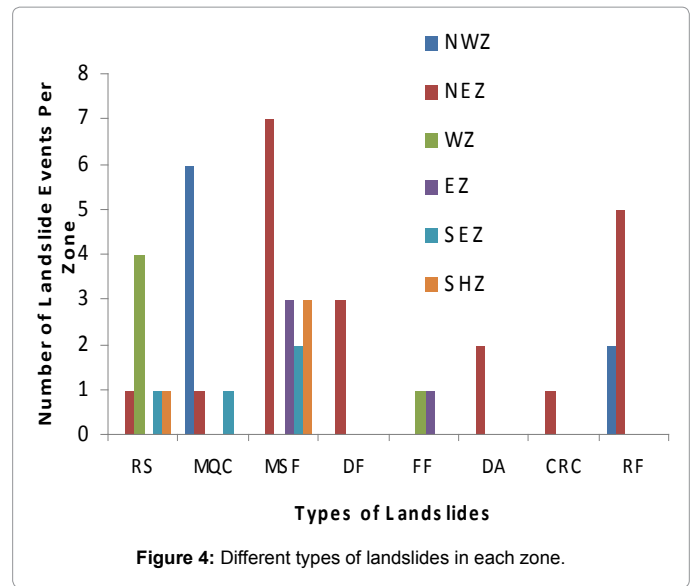
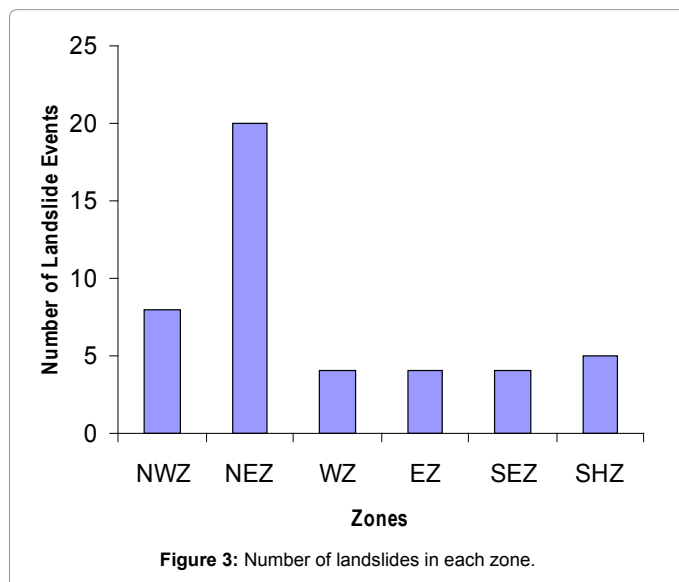
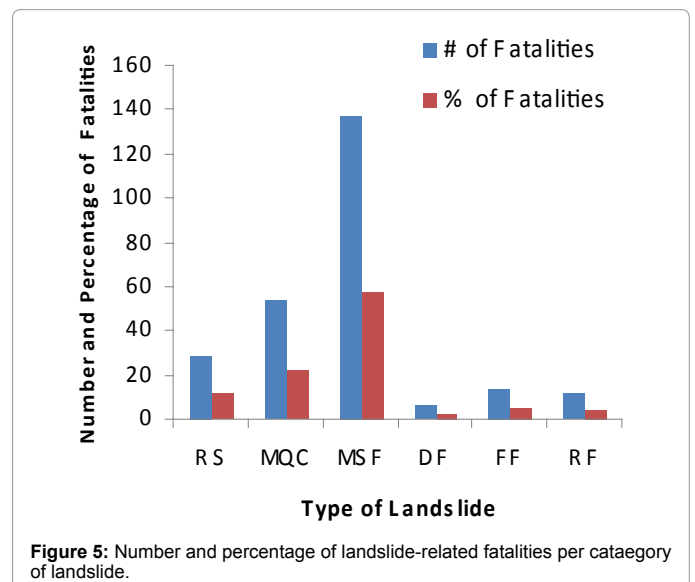
rotational slumps caused more deaths (212 people) than other types of landslides, with most of the fatalities occurring between October and April (Figures 5 and 6). The 45 landslides caused injuries to 142 people and destroyed more than 2018 houses, rendering more than 65188 people homeless. Additionally, more than 3 bridges, 393 hectares of crops, 4 school buildings and roads were lost to these landslides (Table 2). According to CRED [30], there was one landslide event, over the same reporting period, which killed 13 people, and affected 150 others.

Based on the concentration of landslides, 6 zones, namely, western (WZ), eastern (EZ), northwestern (NWZ), northeastern (NEZ), southeastern (SEZ) and southern highland (SHZ) were delineated. Based on the number of landslide events, the NEZ reported more events than other zones in the country (Figure 3). In terms of landslide types, this zone reported more mudslides/flows, debris flow and debris avalanches than other zones. While the NWZ reported higher occurrence of mine collapses, rotational slumps seem to have a common occurrence in the WZ (Figure 4).

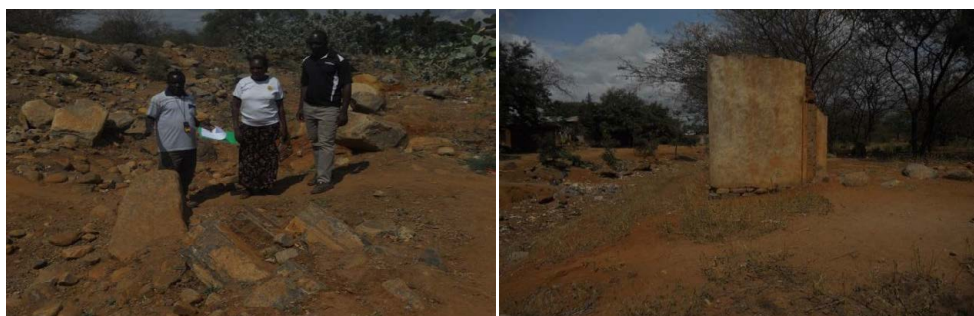
Figure 9: Lower section of Mtowashi natural channel (left); Remnants of dilapidated buildings (right).

the upper section of Mtowashi natural channel filled in by debris The event was preceded by 2-3 consecutive days of rainfall averaging to 90 mm per day [31] and earthquake whose magnitude was not established due to absence of seismometers in the village. On the onset of the event, loud cracking sound was heard and flash lights seen, probably from crushing rocks in the middle portion of the mountains. In the uphill, debris flows were confined in the mountain valleys. Upon reaching the foot slopes the debris over flew the 2 known natural channels- Mtowashi and Shingo (Figure 9) and flooded the low-lying areas of this village. The channels had been in place for many years and were used to pass water through during rainy seasons. It was reported that similar event occurred in the same area about 50 years ago. Human-induced de-vegetation on the SPMs was perceptually reported to underlie these landslides.

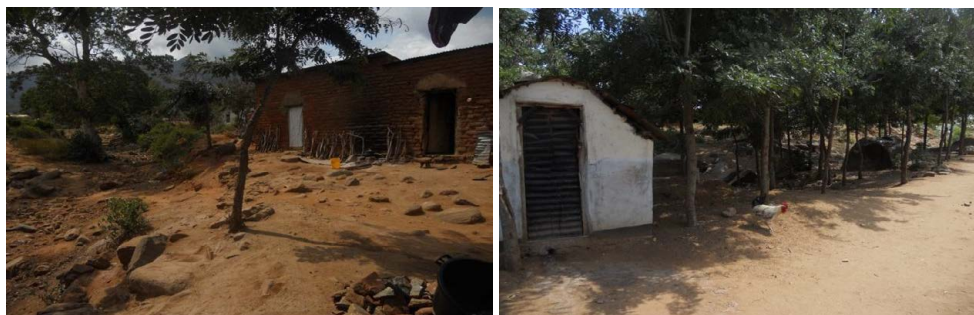
Figure 10: Some of the residential houses constructed after debris flow in Makuyuni village. Part of the Mtowashi natural channel in front of the 2 houses can be noticed.

In addition to loss of property, 2 people lost their lives to this event. Surviving victims were relocated to relatively elevated areas. Trees were planted in the degraded area to stabilize slopes, reduce future landslide hazards, and improve scenery of area (Figure 10). The commonest trees include the Neem (*Azadirachta indica*), acacia species, some *Leucaena* species and *Cassia* species (*Senna Siamea*). These species were preferred to other species because, they have relatively strong physiological tolerance thus, can better survive even on impoverished soil, which is characteristic of this area. Villagers were mobilized and assisted to embark on assisted vegetation regeneration approaches (e.g., establishment and promotion of alternative livelihood options and use of improved stoves) to reduce pressure on forest and other land resources. By-laws pertaining to environmental conservation were set and enforced. As a result of this, some places in Hedaru registered many consecutive years of “no fire incident”.

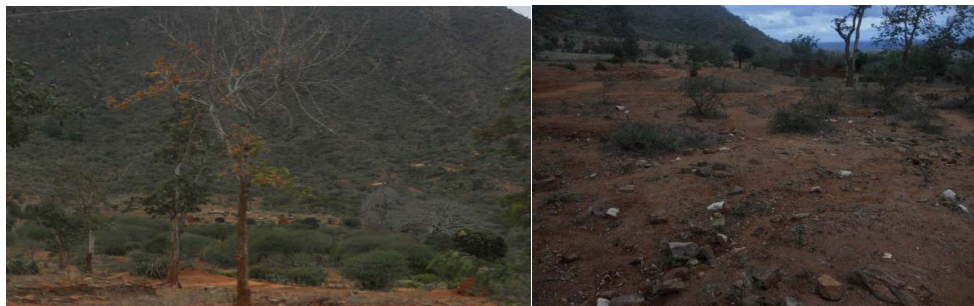
Figure 11: Location of the former Kijomu village (left); Rock fragments deposited during movement of debris (right).

Kilimanjaro region at the foot slopes of the SPMs (Figure 11). The visited landslide is situated at latitudes 0383763 and longitudes 9500046, and an altitude of 816 m a.s.l (Figure 7). The nature of landslide in this village was similar to that of Makuyuni village. An interview with Hassan Omari aged 71 years revealed that the last landslide events occurred in 1930s, 1958 and 1968. According to him, these events were minor and had no significant damage. He pointed out that agricultural activity, which contributed to loss of forests atop the mountains, were and are yet the major underlying factors for landslide events in the village.

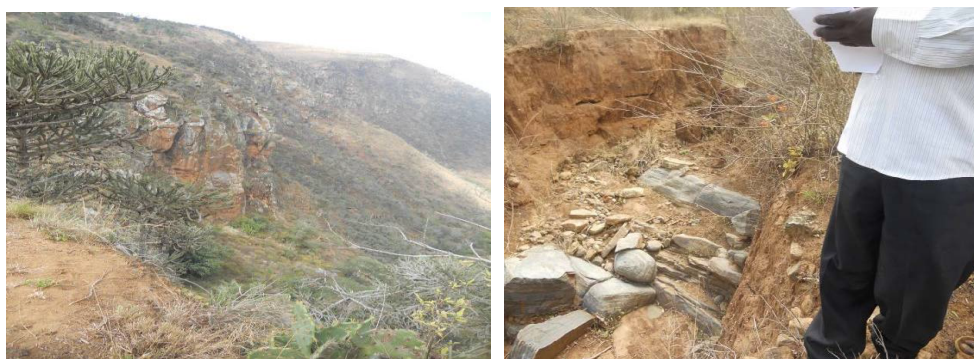
Figure 12: One of the higher elevations in Gonjaza village (left) and Gully erosion (right).

The only notable landslides occurred in 1998 and 2013, and were perceptually triggered by rainfall. An eyewitness reported materials constituting mud and rocks of different sizes moving from highlands to lowlands through natural channels. The incident caused neither casualties nor loss of property as it occurred in uninhabited area. The serious and emerging threat to this village is gully erosion (Figure 12).

Unstable slopes and deeply weathered soil with little or no vegetation to hold soil together underlie gully initiation and development in this village. Villagers reported development of new gullies due to human-induced loss of vegetation on mountains.

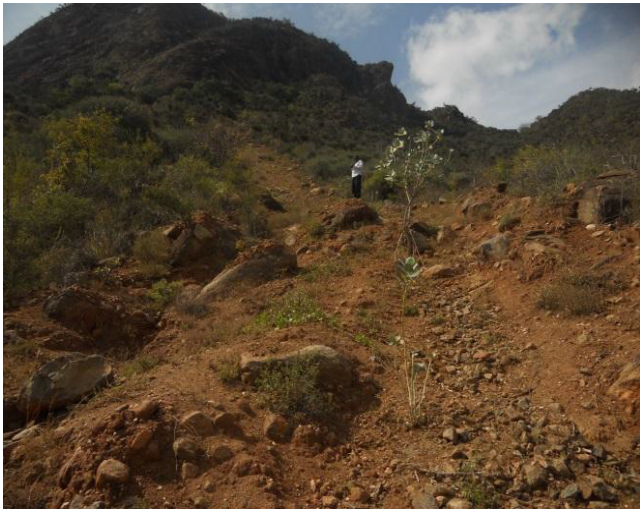
Figure 14: A gully created on the scratched surface.

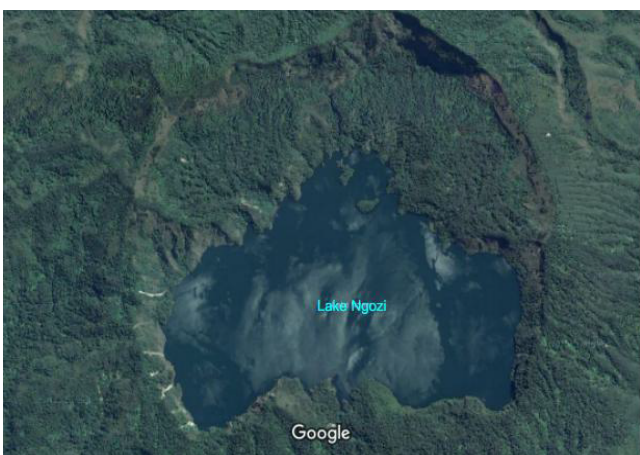
Figure 16: Ngozi Crater (the light-coloured strips on the SW and NW parts of the Crater. These strips are possibly landslide scars [14] (image source: Google Earth in year 2014).

mapped and described in the SHZ (Figures 15-17). Of these, 15 were identified in six areas (labelled on map as Inyala, Iziwa, NC, Igoma, Mt. LS, and Mt. Rng) using Google Earth visualization and analysis. These occurred in areas around the 3 large volcanoes (Rungwe, Ngozi, Kyejo) and around Mt. Livingstone. These landslides were triggered by tectonic and seismic activities, resulting into Rungwe sector collapse and avalanches in the Holocene. Additionally, the most recent earthquake activity in December 2009 in the northern Malawi might have triggered small landslides along the steep inner slopes of the Ngozi Caldera as seen in Figure 16 [15,32]. The remaining 4 landslides (labelled on map as Chunya, Ileje, Lwangwa/Lupata and Mwakaleli)
